The Effect of Heat on Flooring

In this article I am going to share with you the effect heat, in several different forms, had on carpet and floors I have inspected.

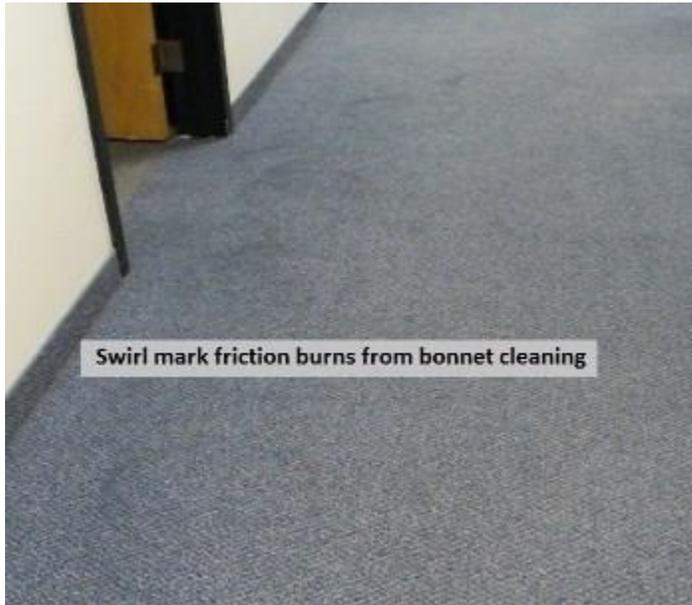
In my last article about bonnet cleaning I used this photo. I have seen swirl marks and crescent-shaped friction burns in carpet because the operator was not using sufficient detergent to lubricate the bonnet. Too much friction between the bonnet and the carpet melted the carpet yarns.

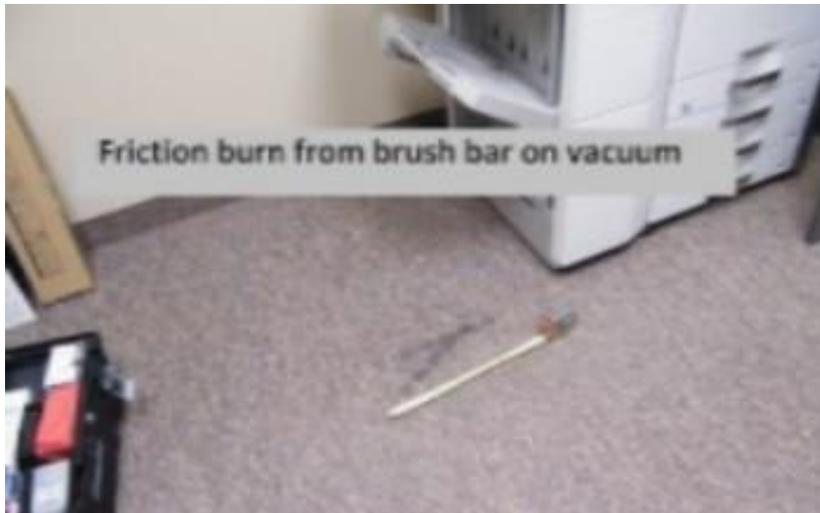
This photo also shows friction burns in carpet, however this time it was caused by the revolving brush bar on the upright vacuum. The vacuum the copier repair person used. He forgot the brush bar continued to revolve when he was using the on-board attachments while vacuuming out the copier.

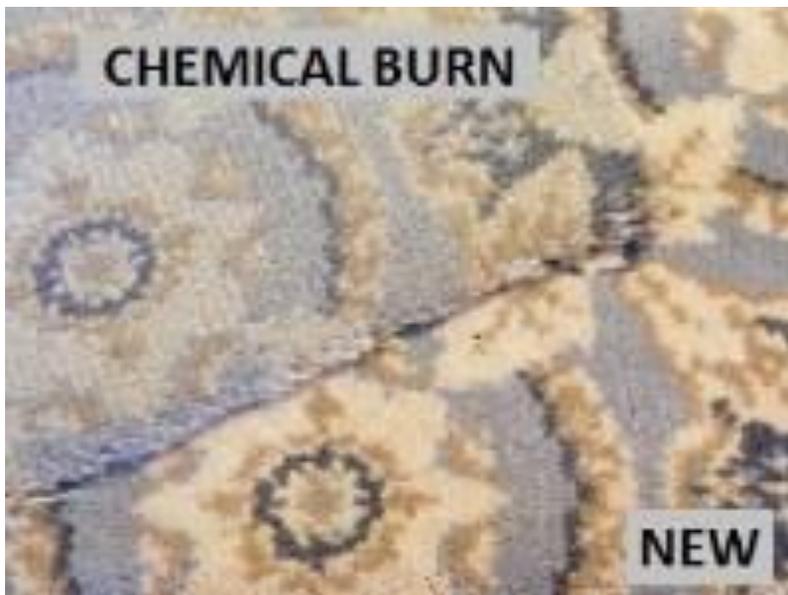
In this photo, it shows carpet made with wool damaged due to improper chemistry. The pH of the chemical the cleaner was repeatedly using was too alkaline. The wool fiber was chemically burned.

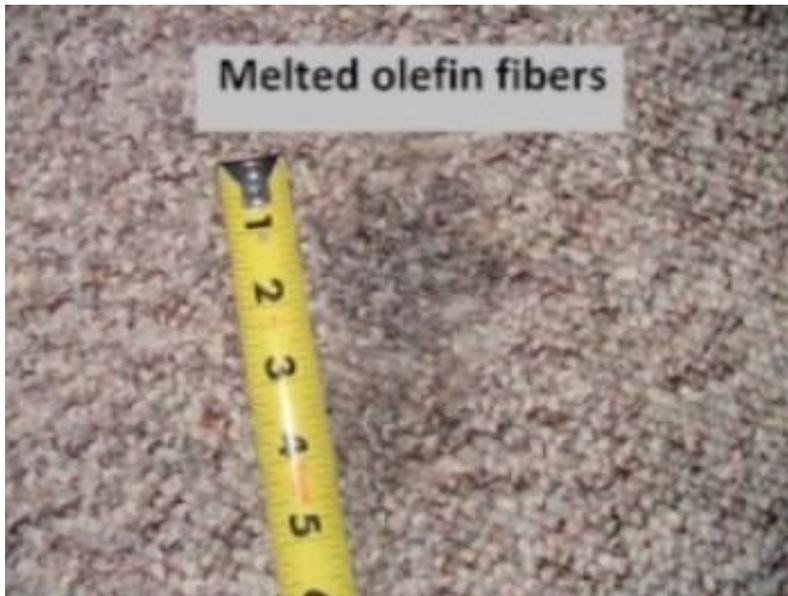
This photo shows the Berber style, olefin/nylon carpet to be melted. I was asked to determine if a certain over-the-counter solvent based spot remover melted the carpet fibers. Ahhh....no. It was the teenager who used a hair dryer to flash dry the carpet before mom got home. Olefin has a very low melting point.

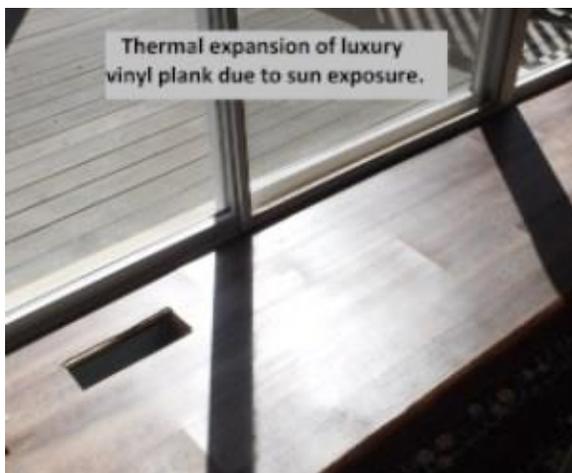
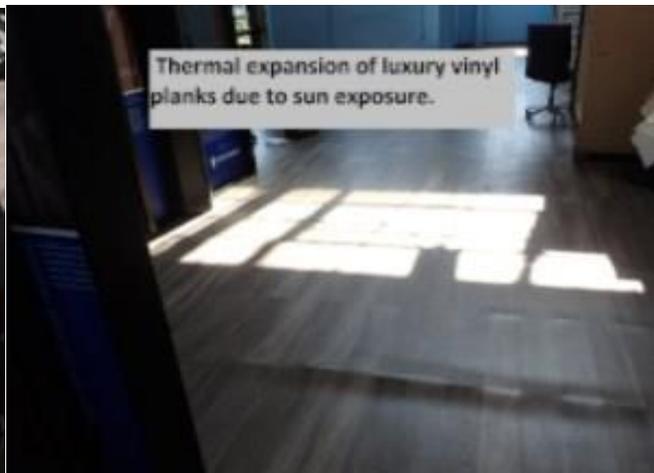
In the photos above, the caption says it all. In all the installation guidelines I have read, they specifically state one way or another, "do not install in locations exposed to direct sunlight". In the photo to the right, that is doable by simply closing the draperies. Not so much in the photo to the left as this floor was installed in a renovated warehouse where the windows letting in the sun are 30 or more feet above the floor. Unfortunate as it may be, some flooring types are just not good candidates for certain environments.

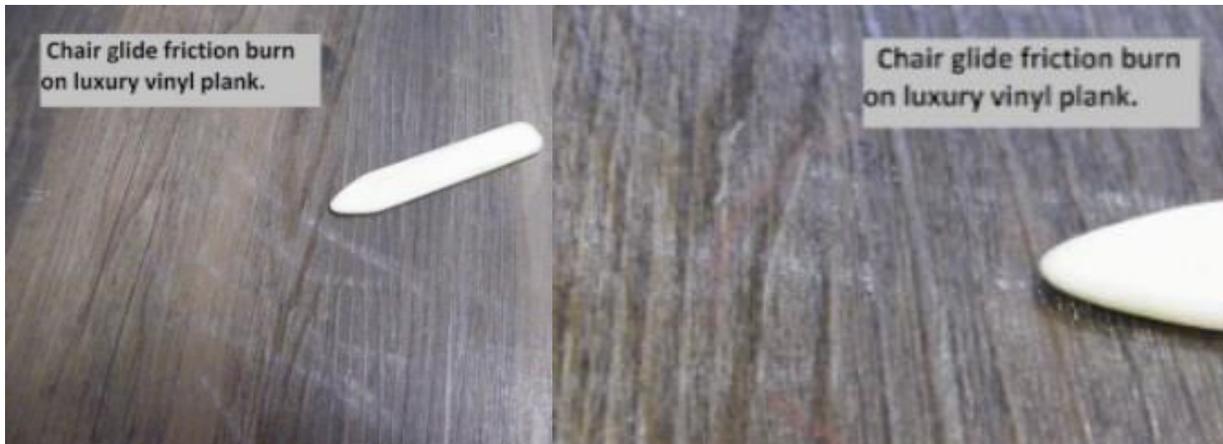
In the two photos above, a heavily textured LVP floor installed in a conference room has friction burns on it. The four 1/2 inch wide by 1 inch long plastic glides on the bottom of the chairs created enough friction to permanently damage the vinyl. Picture a person (200lbs. or more) seated in the chair sliding forward and/or backward. That is asking each glide to support 50 or more lbs. each. Due to the heavy texture of the floor, the glide was only supported by and skimming over the highest ridge points. So they switched to felt glides. There was so much friction between the felt and the ridges on the floor the felt became impinged to the ridges. Nice floor, wrong application.

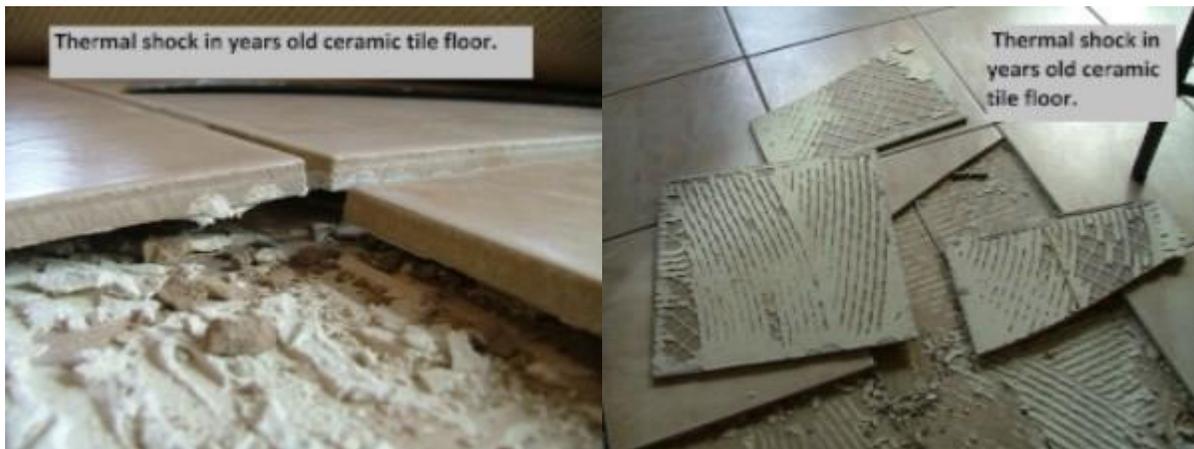
The consumers said the noise was as if a gun had gone off in the dining area of the kitchen when the ceramic tile suddenly "blew" off the subfloor. No doubt there were some installation issues that may have exacerbated the failure but the main cause was thermal expansion. This occurred at the end of January. The windows in the dining area face south. They had some pine trees removed the previous year. The trees shaded the dining area from the low sun that occurs during the winter months. The coldest days of the year in northeast Ohio are when the sun is shining bright because there isn't a cloud in the sky to insulate the earth. I know this because I live in a passive-solar home and rely on the sun's rays to help heat my home in the winter. In the case of the floor above, thermal expansion of the tile with no accommodation/expansion spacing...something has gotta give.

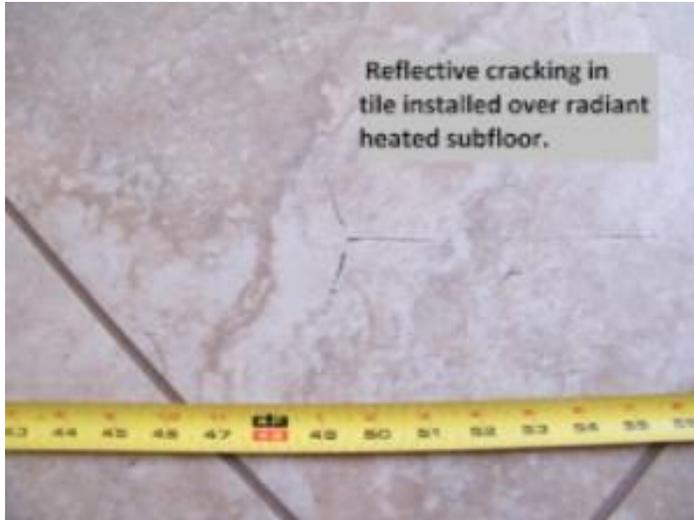
This photo shows a cracked ceramic tile. The crack occurred directly over the OSB subfloor joints. Radiant heat tubes are installed directly to the underside of subfloor. The radiant heat system rapidly overdried the subfloor causing the sanded flat joints to shrink and pull anything installed over it down with it, and when the floor shrunk in thickness it caused reflective cracking in the tile.

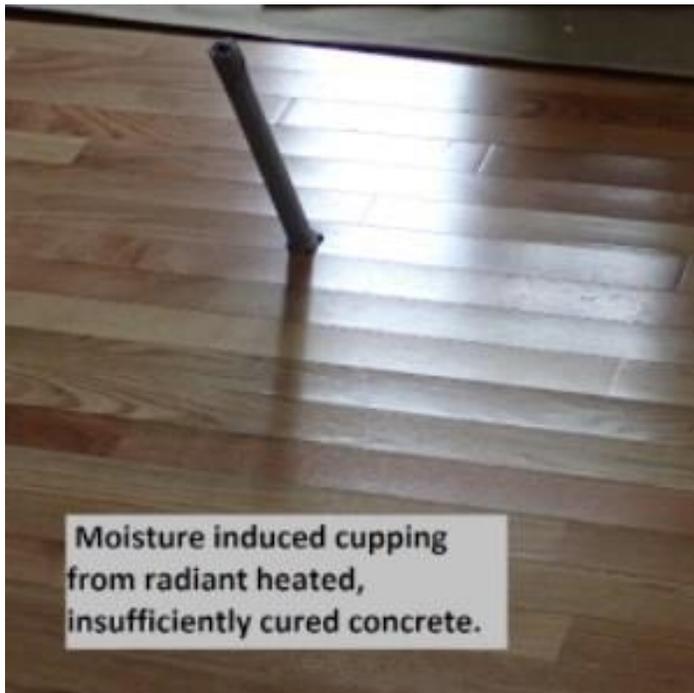
This one is a head shaker and I think someone needs dope slapped. What was the installer thinking? The concrete was less than 60 days old when the installer decided to install this floor over radiant heated concrete. The radiant heat drove the moisture out of the concrete up into the wood. The wood is ruined, very sad.

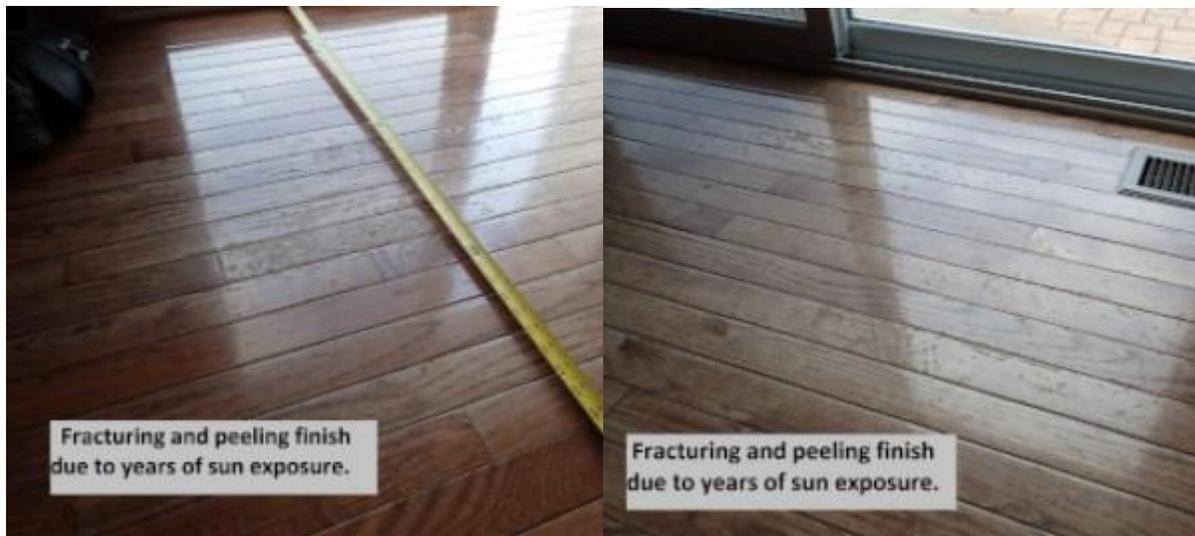
I am certain this floor was lovely when it was first installed 10 years ago. After years of direct sun exposure through the patio doors the finish on the floor is finally giving up and can't take it anymore. Remember polyurethane finishes on wood floors are plastic with ultraviolet light inhibitors but they can only take so much abuse. They eventually become brittle, fracture and disintegrate.
